FRANK MILNE DAM

HOLT COUNTY, MISSOURI

MO. 11029

**PHASE 1 INSPECTION REPORT
NATIONAL DAM SAFETY PROGRAM**

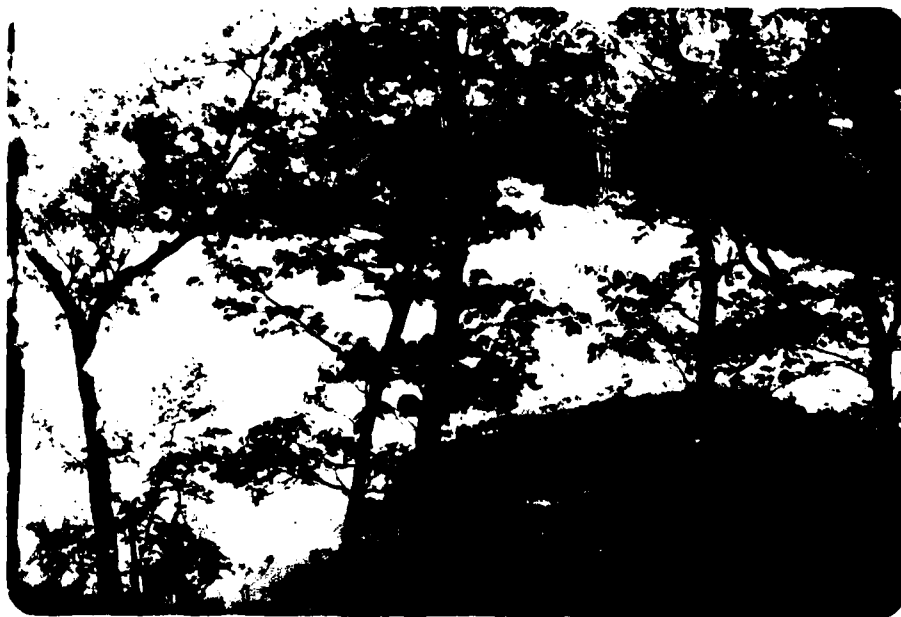
PHOTO NO. 11 - UPSTREAM SLOPE FROM RIGHT END

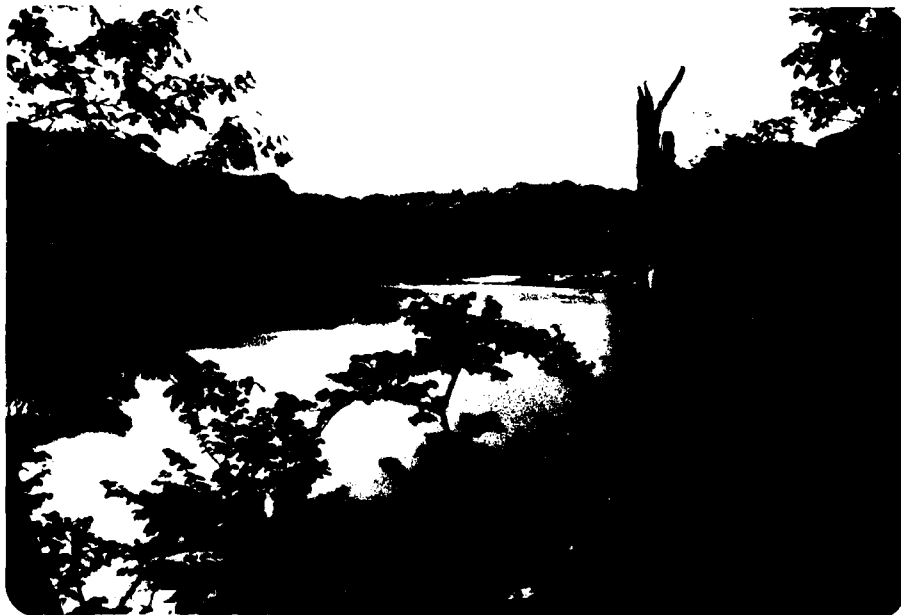
PHOTO NO. 13 - LOOKING UPSTREAM FROM LEFT ABUTMENT
